Home Inspection Report

123 Any Street, Any City, Any Country

Attic, Insulation & Ventilation

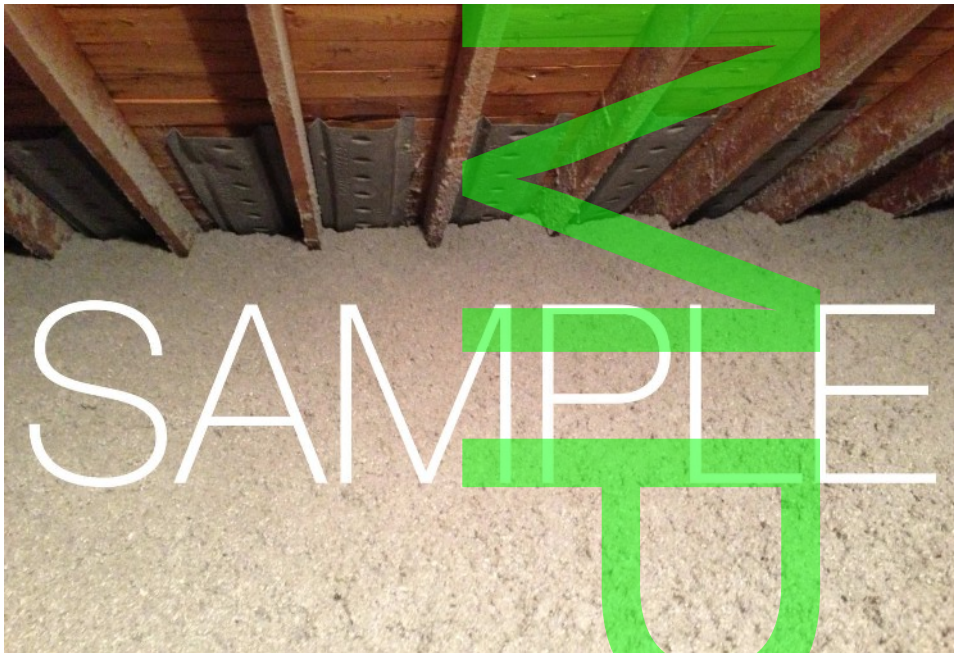
ATTIC EAVE

The attic was examined and no major defects were found. Preliminary inspection indicates that the baffles are present (see diagram below). Insulation is of reasonable depth, and prevents thermal bridging (see image below). Roof Sheathing appears to be in good condition, with no signs of moisture entry. Client did not request thermal imaging to be performed, and this limits the ability to inspect insulation elsewhere in the home. Ventilation stacks are confirmed to be attached, and of proper types (see images next page).
